Subject Asbestos Containing Materials Survey April 2004
 MDEQ – LOE Contract
 Carter Color Coat Site

**ASBESTOS CONTAINING MATERIALS
NESHAPS SURVEY AND BULK SAMPLING
COLLECTION RESULTS REPORT**

**CARTER COLOR COAT
6051 Hastings Street
Detroit, Michigan**

PROJECT # A-040406

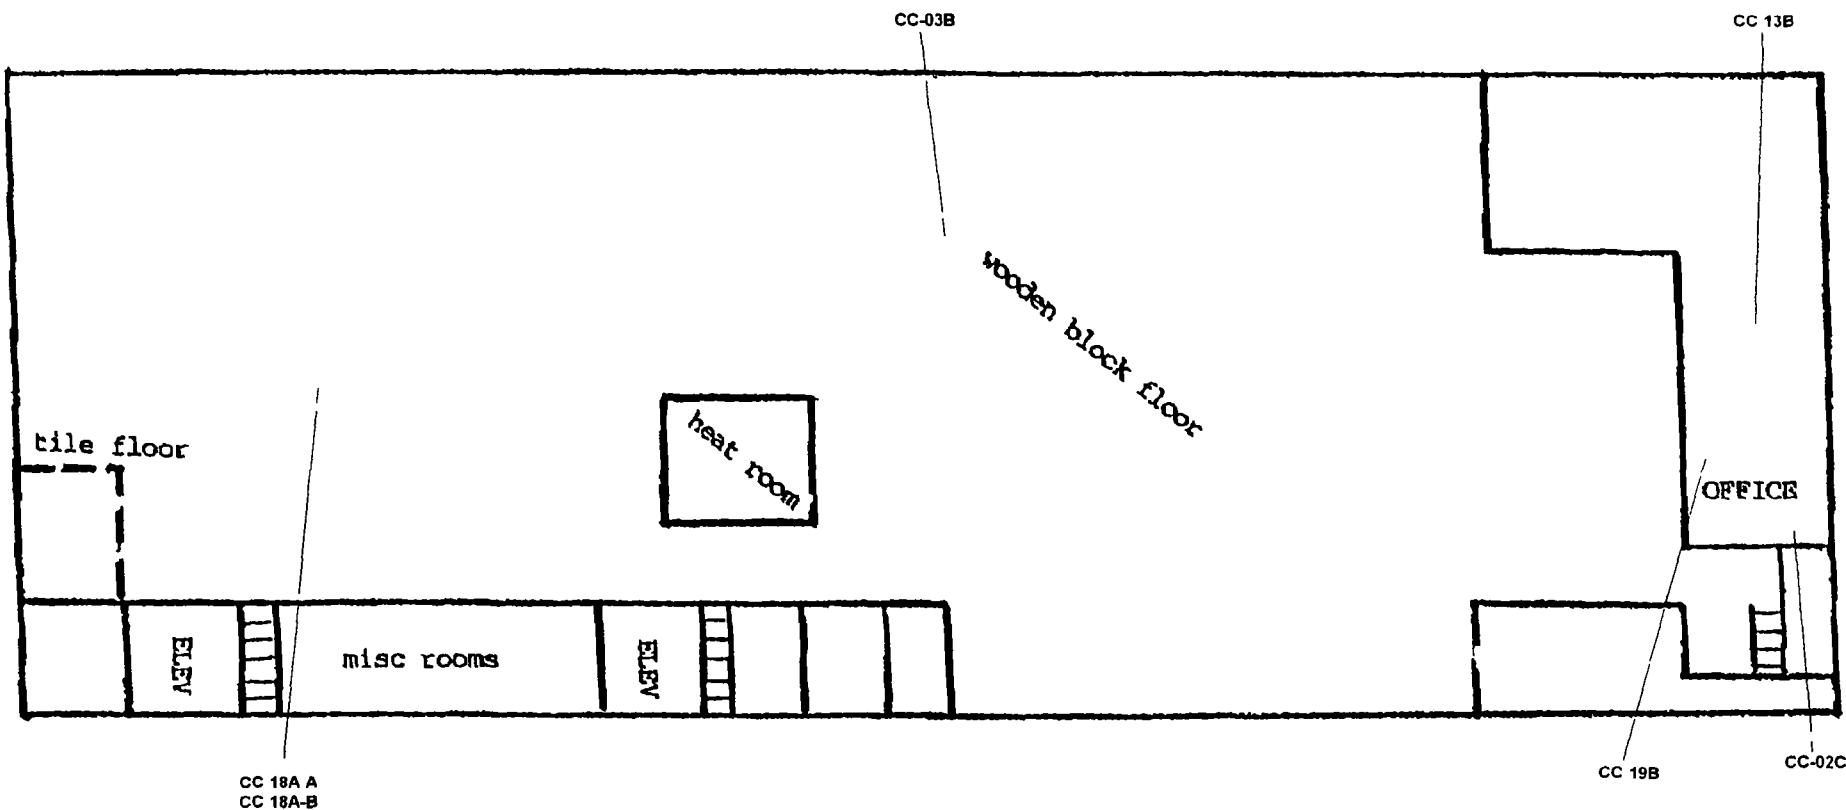
CARTER COLOR COAT
6501 Hastings, Detroit MI
5th Floor

- 14 Material** Miscellaneous Material
Type 9 x 9 Floor Tile Burgundy
Sample ID CC 18A A CC 18B A
Asbestos Content 3 4% Chrysotile
Location 2nd 3rd 4th and 5th Floor Office Work and Restroom Areas
Quantity 8750 S F
Condition Damaged

CC 18A A
CC 18A-B
